Construction Inspection Report

CME Project No.:	2018700.400
Project Description:	Webster First Federal Credit Union, 41 East Main Street
Date:	June 25, 2020
Time:	3:00 pm – 3:30 pm
Weather:	Sun, 83° F
Submitted By:	K. DeCarli

CME Project No.:	2018700.400
Project Description:	Webster First Federal Credit Union, 41 East Main Street
Date:	August 11, 2020
Time:	8:45am
Weather:	Sun, 80°F
Submitted By:	K. DeCarli

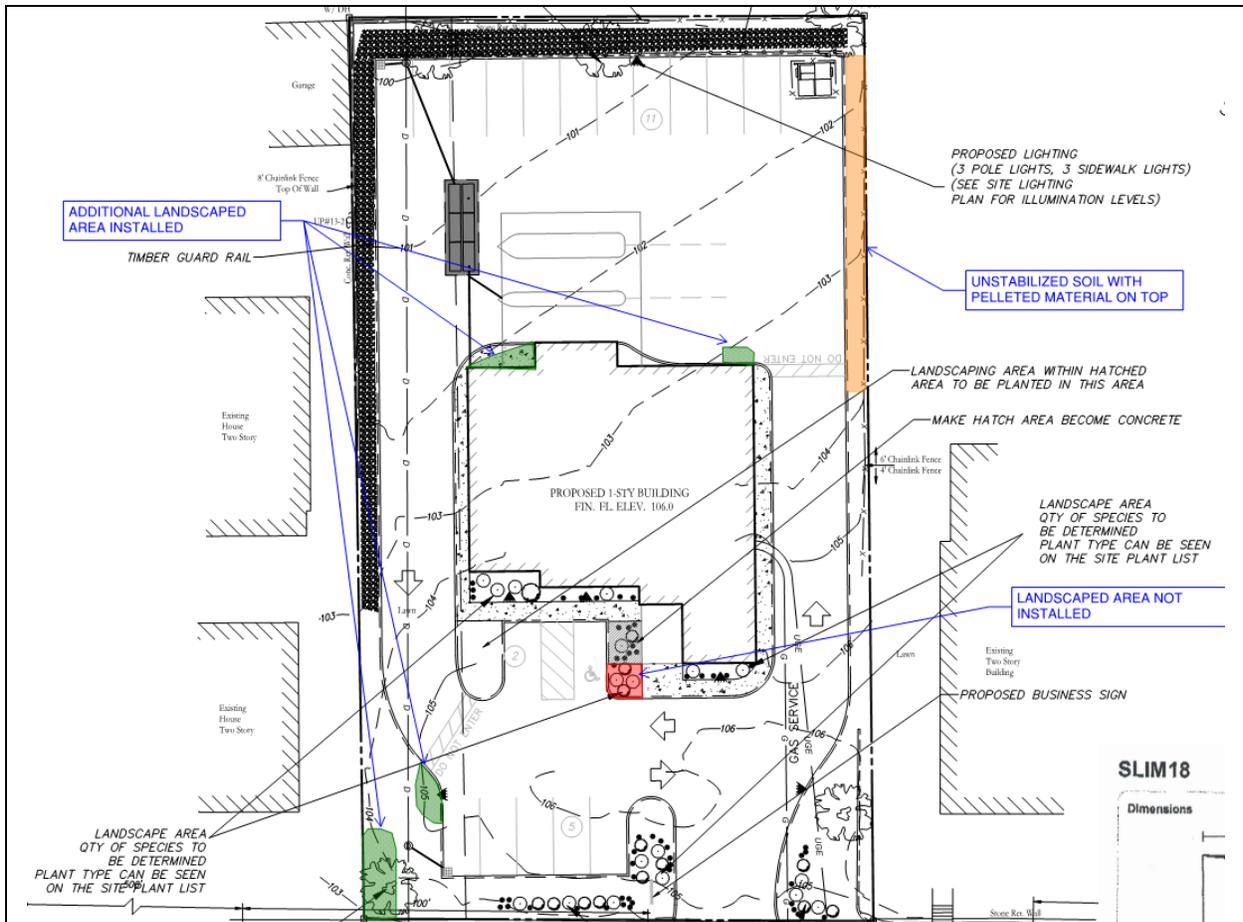
Image 1. Markup of approved Landscape plan

Description of Work
Construction of the credit union was completed in late 2019. The landscaping and plantings were recently installed. An inspection was conducted to ensure the landscaping and planting met the intent of the plans approved by Webster Planning Board.
Overall, the landscaped areas, plant types, and quantities appear to meet the intent of the approved plans. All landscaped beds have been finished with either wood mulch or stone mulch. Sod is in good condition and an irrigation system is in place. In several locations, additional landscaped beds with plantings were constructed, these locations are marked in green on the site plan below. One landscaped bed shown on the site plans was not constructed, as marked in Image 1.
Along the northeast property boundary, behind the bituminous curb, the soil has not been stabilized with grass or landscaping. A pelleted material was present, but no vegetation had sprouted. This area must be landscaped.

On the rear property line, the approved site plans called for three trees of 2.5-3” caliper. No trees were planted in this location.
The irrigation system must be fine-tuned to eliminate spray on the abutter’s driveway on the southwestern property boundary.
Digital photos were taken, several are included below.

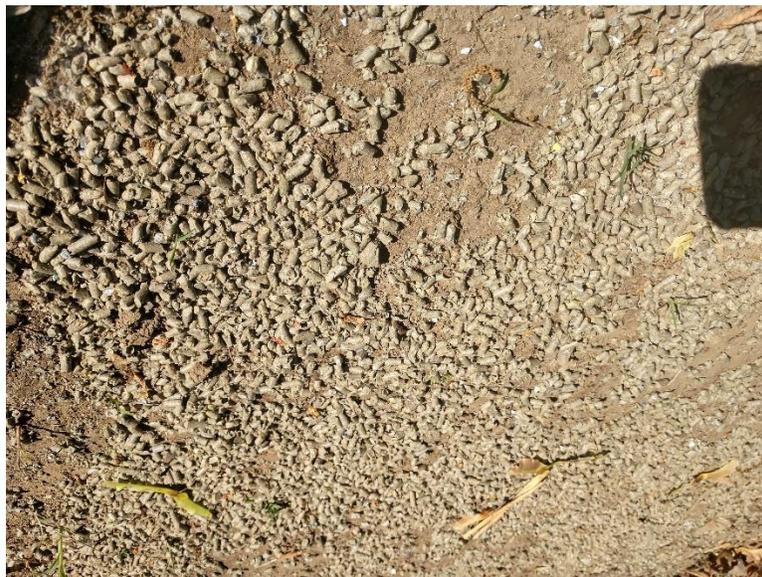
Photo 2. Unstabilized soil with pelleted material on the northeast boundary

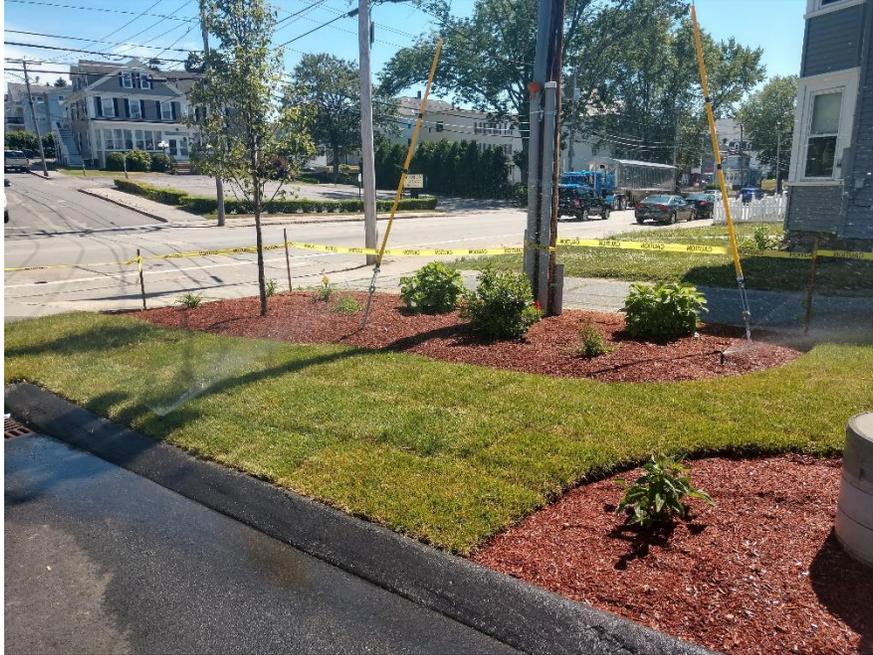
Photo 3. Additional landscaped areas installed in the southwest portion of the site

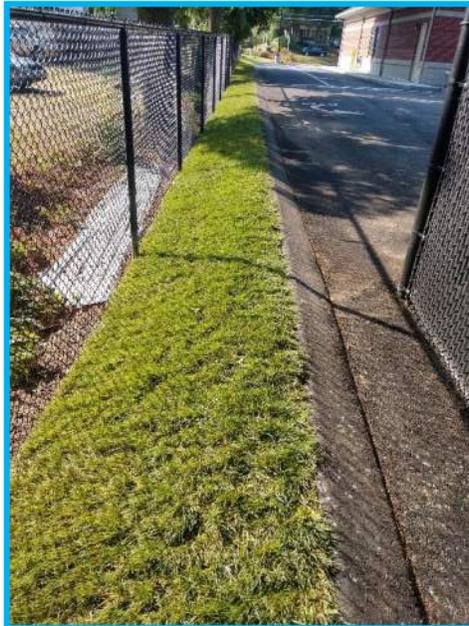
Construction of the credit union was completed in late 2019. The landscaping and plantings were recently installed. An inspection was conducted on June 25th, 2020 to ensure the landscaping and planting met the intent of the plans approved by Webster Planning Board. During that inspection it was noted that, along the northeast property boundary, behind the bituminous curb, the soil was not stabilized with grass or landscaping. A pelleted material was present, but no vegetation had sprouted. This location has now been stabilized with sod.

Photo 1. Sod at northeast property boundary
